OBSERVATION AND AUSCULTATION OF THE STATE OF CONSERVATION OF ANCHORAGES IN ROAD GEOTECHNICAL STRUCTURES IN THE ASCENDI NETWORK

Jorge Dias

ASCENDI

/04.1. Anchored Wall - PK 000+299 - A4, Grande Porto Concession

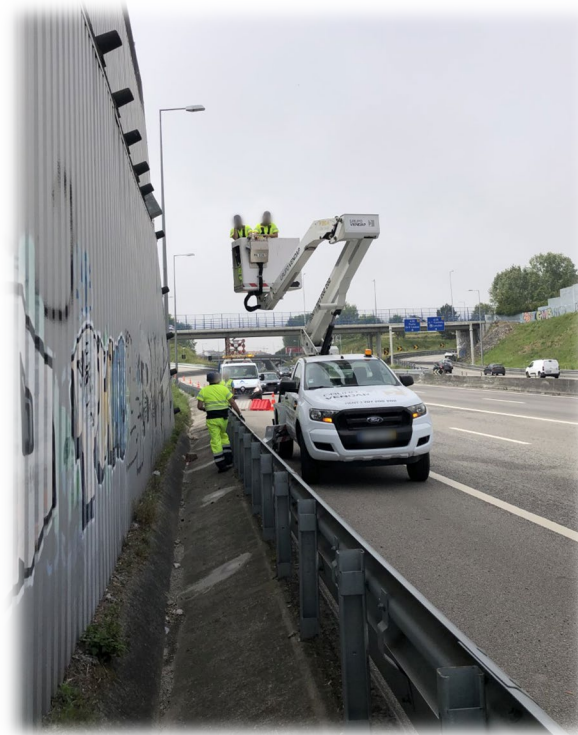
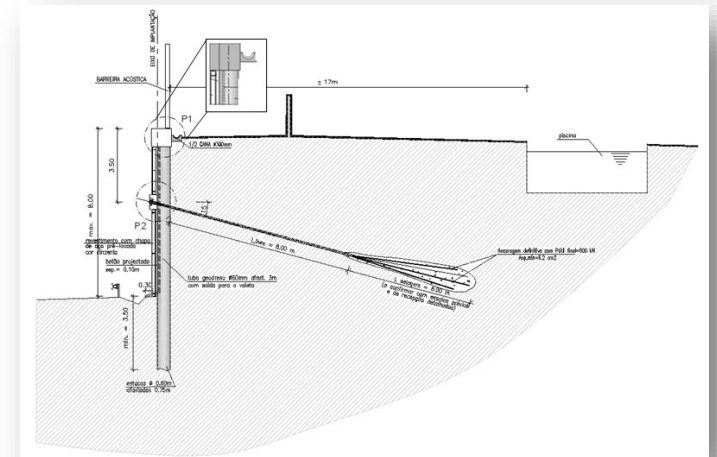
- Maximum height= 8m;
- Length = 73m;
- Pile curtain 0,60m in diameter, spaced 0,75m;
- Anchored beam, with 45 anchors, spaced 1.50 m apart and load 600 KN (project);
- 6 Load cells.

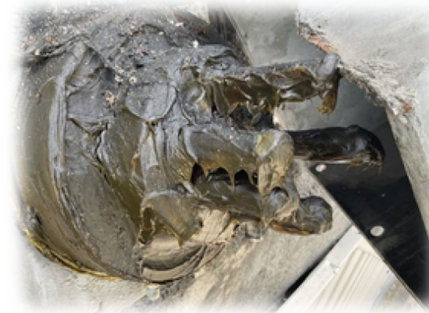
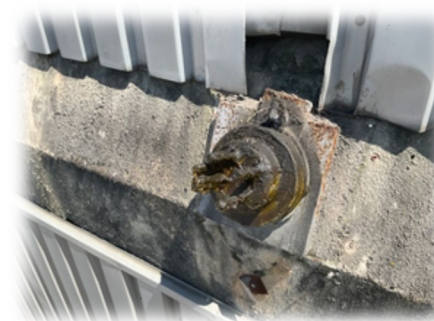
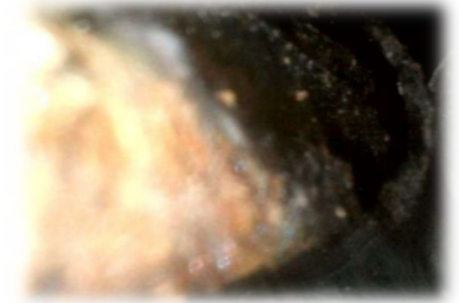
- Visual Inspection;
- Endoscopic test;
- Electrical Resistance Test;
- Load Cell Reading.
